WATER AUDIT REPORT

Centurion University Of Technology And Management Village Alluri Nagar, R Sitapur, Via- Uppalada, Paralakhemundi, Odisha 761211 Odisha - 761211

Year 2022-23

CONSULTATION and REPORT by

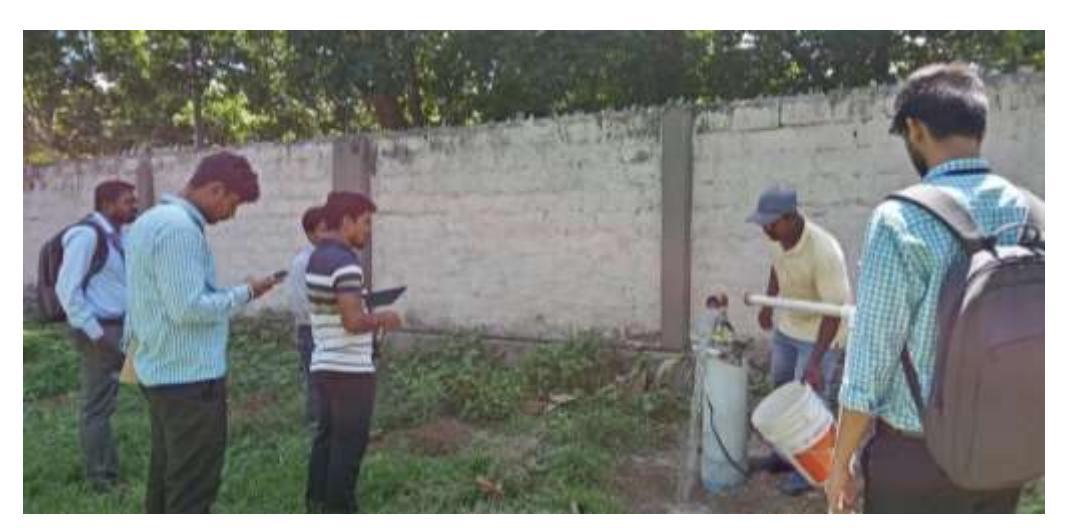
The quantity of water yielded by each water source is listed in the table below:

Figure: 1.3 - Verification of quantity of water yielded from each water source

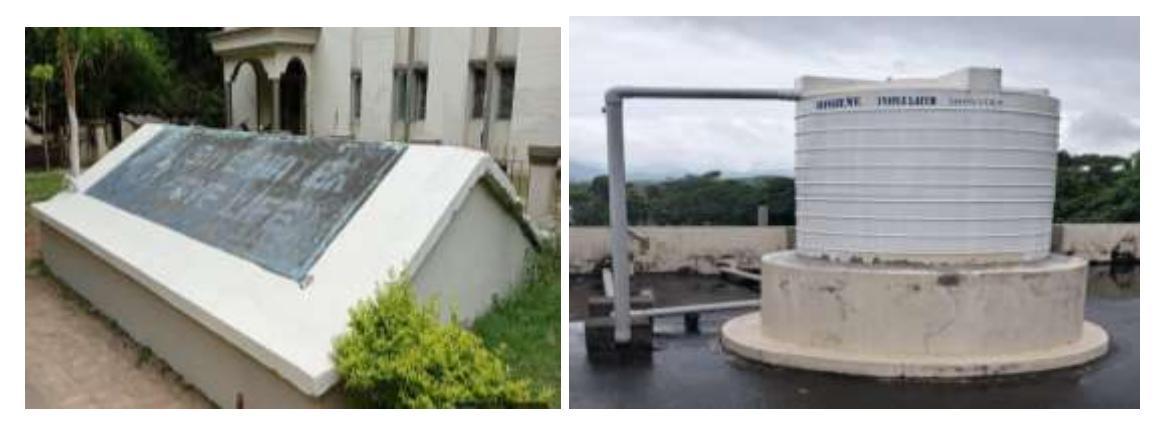
The campus has widely distributed storage tanks. Water drawn from the borewell is first stored in ground level tanks. Then it is pumped up to overhead tanks kept over all buildings which then supply water to the building water usage points by gravity. Water is pumped up from borewells in some overhead tanks.

The total water storage capacity, built into the 33 nos water tanks is 9,78,000L. The breakup of water storage capacities in tanks is as given in the table below:

Figure: 1.4- Image of Overhead Tank and Sump

Automatic shutoff switches in overhead tanks

Though some storage tanks have indicators or float valves to alert people about overflows and prevent them, and auto shutoff motors / switches for overhead tanks can make the task of preventing water overflows much easier. This should be done for all overhead tanks since they are very difficult to monitor

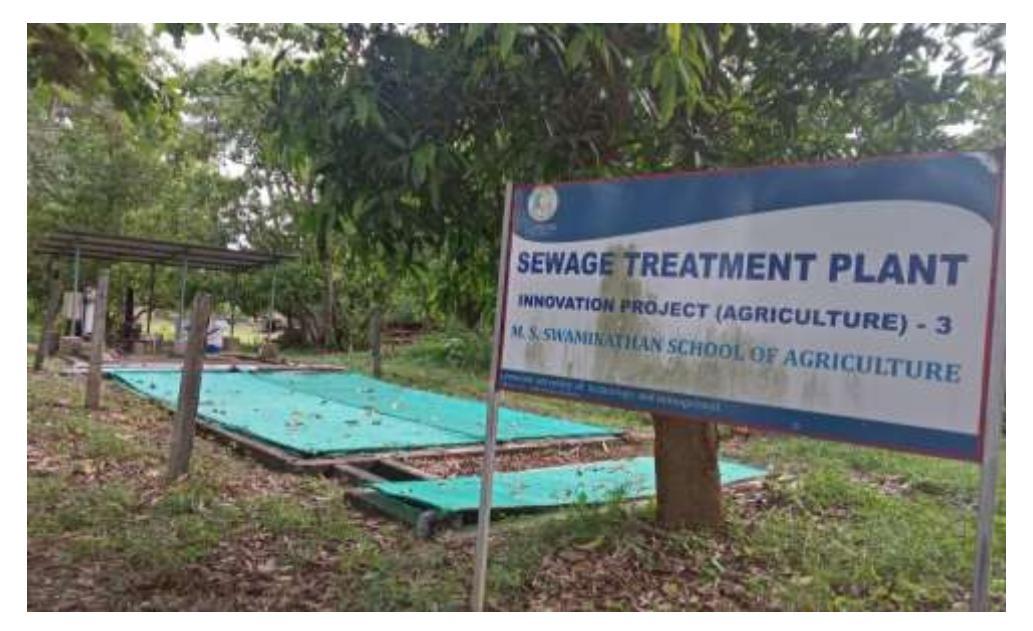
The campus has a separate storm water and sewage drainage system. The sewage waste water generated from various departments like canteen, mess, and washrooms, hand-washing points, bathrooms, drinking water points and RO reject water is discharged into the sewage drain line. The sewage drainage system ends at the STP plant where it is treated. The treated wastewater is stored in a storage tank and, as per need, reused for gardening and irrigation. Surplus treated water is placed in a pond outside the campus where it helps safely recharge to groundwater.

Figure: 1.4 - Sewage Water Treatment

The campus has a Sewage Treatment plant to treat all its wastewater. The plant has a capacity of 300kL per day which is more than the waste water generated daily in the campus. Capacity utilization of the plant stands at 80% i.e. 240 kL of wastewater is treated daily.
